Roof wind damage mitigation: Lessons from Hugo

Studies on Hurricane Hugo reveal that inadequate attention by designers was the predominate cause of roofing problems in and around Charleston, S.C.

by Thomas L. Smith and
James R. McDonald

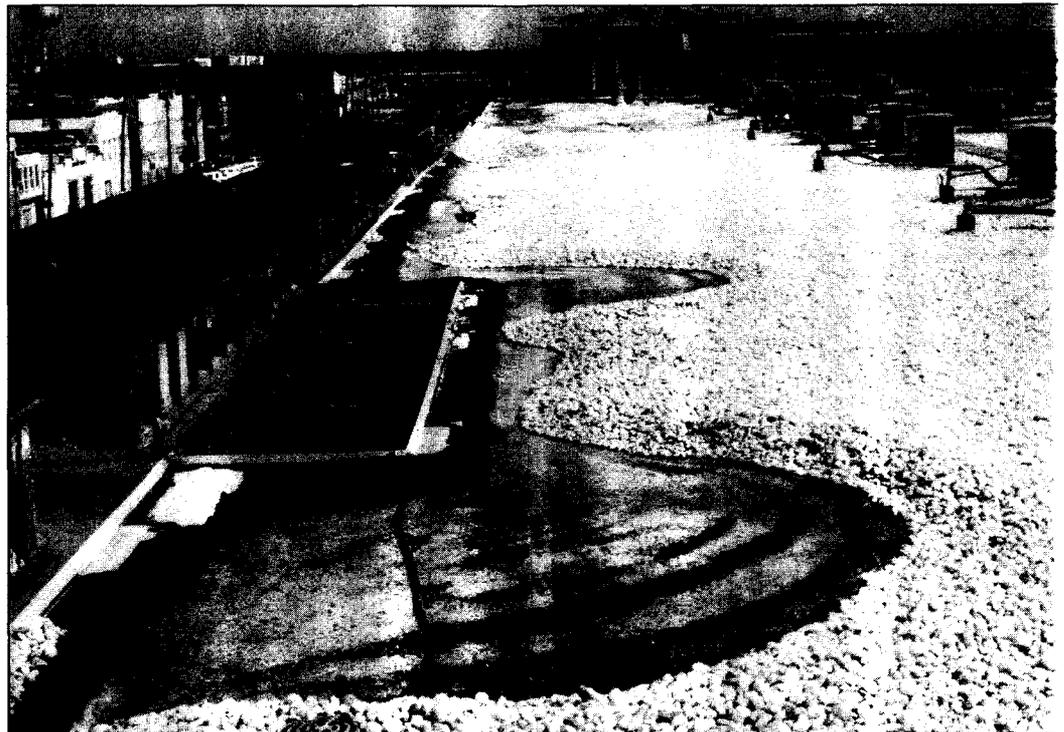
Single-ply membrane ballast (aggregate) blow-off. Several aggregate ballasted, single-ply membranes that experienced significant ballast blow-off were investigated. These large aggregate (ASTM D448, number 4) have the potential to cause significant injury and building damage.

Ballasted EPDM system. Much of the ballast was scoured and several stones blew off the roof.
